11 July 1969

MEMORANDUM FOR : Chief, WCPO

After testing the Advanced 918 Light Table Prototype and reviewing the specifications, we arrived at the following list of items to be modified or repaired.

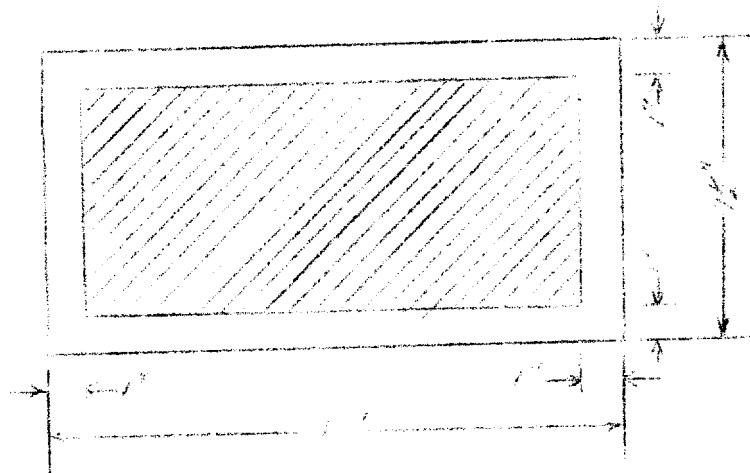
g. The illumination system must provide a maximum illumination of at least 2,000 ft. lamberts within a 2" radius of the geometric center of the illuminated area. The maximum linear brightness gradient must not exceed 15% between any two measurements taken within the shaded area shown on the diagram below, nor 25% anywhere within the illuminated area.
